*This article appeared in Properties Magazine, August 2009 issue.*

# Towering Achievement

## Extensive renovation program revives Downtown Cleveland landmark

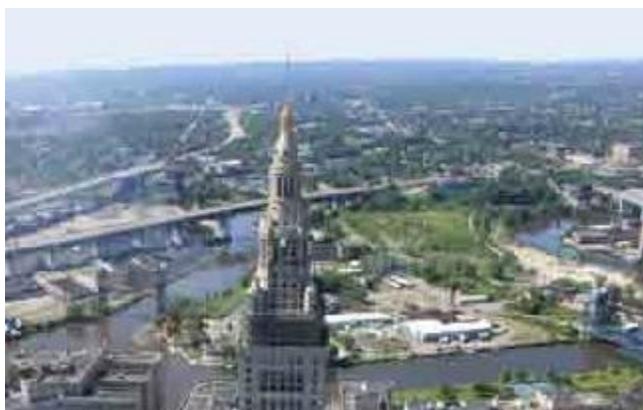
**RELIC RENEWED** The Terminal Tower has battled the harsh North Coast environment for 80 years, and time has taken its toll. Ongoing repair and restoration work is underway to prepare the structure for coming decades.

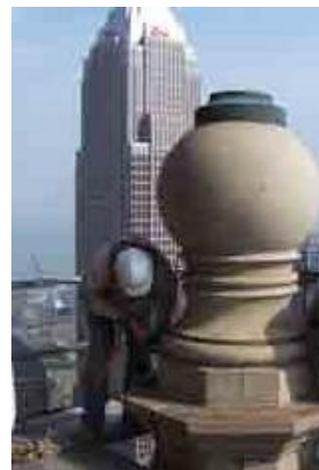
**ALLOWING ACCESS** Scaffolding went up from the 37th floor to the top so engineers could "touch every inch of the façade" to determine the extent of water damage.

With historic tax credits granted, Provenzale sent out bid packages, the first being for scaffolding from the 37th to the 52nd floor, erected by January 2006 and becoming a familiar Cleveland skyline sight. Other bid packages included painting, patching and application of liquid plastic, replacement of 16 upper and 16 lower exterior columns with fiberglass, and replacement of decorative hanging terra cotta with fiberglass shapes, according to Dave Provenzale, who is handling the Terminal Tower project for Provenzale Construction.

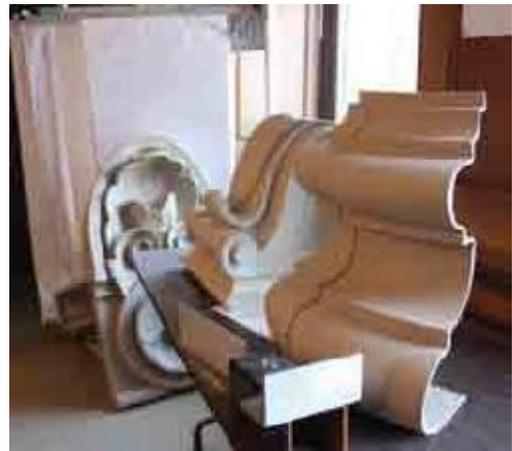
MATERIAL IMPROVEMENTS Fiberglass cornices and other shapes, supplied by Architectural Fiberglass Inc., were used to replace damaged terra cotta.

Replacing terra cotta with terra cotta was no option, as the steel holding the terra cotta could no longer support the weight. The alternative: fiberglass cornices, with embedded aluminum extensions that would bolt to new steel. Lighter and easier to manufacture and install, fiberglass pieces would remain watertight and allow for removal of any heavy, hanging material. Architectural Fiberglass Inc., of Cleveland, was awarded the contract to supply the cornices and other fiberglass shapes for the project.
